# A REVIEW ON PILE FOUNDATION DESIGN IN LIQUEFYING SOIL

## ABSTRACT

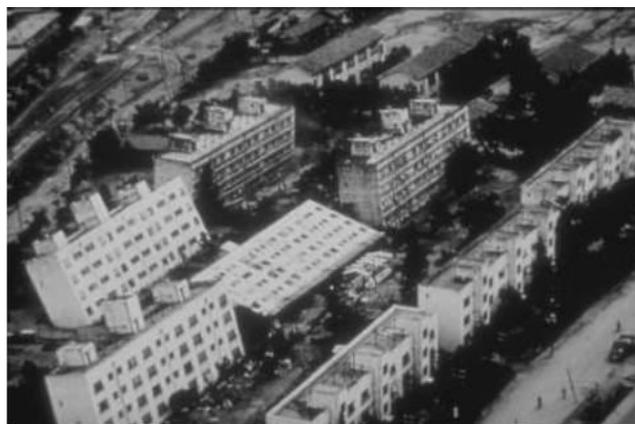
**Fig.1:- Tilted apartment buildings**

Pile foundations are primarily designed to transfer vertical loads from the superstructure to the bearing stratum. For this reason, piles are relatively vulnerable to lateral loads such as those imposed by ground shaking during strong earthquakes. In the case of soil liquefaction, this vulnerability is particularly pronounced since the loss of strength and stiffness in the liquefied soil results in a near complete loss of lateral support for the embedded piles. It is known from previous earthquakes that liquefaction can cause very large loads on pile foundations, both from inertial loads from the superstructure and from lateral displacements of liquefied soil. The extensive damage and failure of piles have affected numerous bridges, buildings and storage tanks in the past. One such example of foundation failure involving toppling of apartment blocks due to liquefaction during the 1964 Niigata Earthquake is presented in Figure 1.

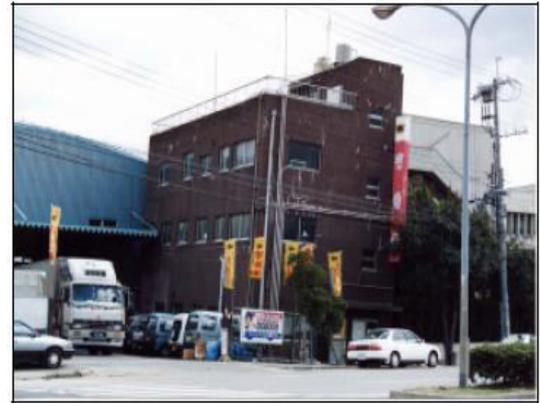
**Fig.3: Failure of Pile Foundation In Level Ground, Bhuj 2001 Earthquake**

It was observed that pile foundations collapsed even in level grounds in a similar way to that observed in laterally spreading grounds. After the detailed investigation of the failure of piles during 1995 Kobe earthquake, it was found that in the liquefied level ground, most PC piles (Prestressed Concrete pile used before 1980's) and PHC piles (Prestressed High Strength Concrete piles used after 1980's) bearing on firm strata below liquefied layers suffered severe damage accompanied by settlement and/or tilting of their superstructure. Figure 3 shows the failure of a piled foundation in a level ground. The foundation tilted in the direction of the asymmetrical mass i.e. in the direction of the eccentricity of vertical loading. It is surprising that a piled foundation collapses in a similar way in level ground i.e. in absence of lateral spreading and in laterally spreading grounds i.e. in the presence of lateral spreading. If lateral spreading is the main cause of failure, it is most unlikely that a piled foundation will collapse in level grounds. It must also be noted that most of PHC piles which had a high bending strength also failed.

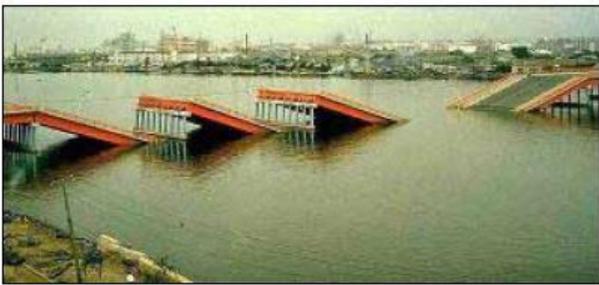
**Fig.5:-Failure of the Showa Bridge after the 1964 Niigata Earthquake.**

The example of the failure of the Showa Bridge (Figure 5) is extensively used to illustrate the effects of

lateral spreading loads to piled foundations. The bridge was built over river Shinano and was completed just a month before the earthquake. The bridge had a width of 24m and total length of 303.9m. The superstructure of the bridge consisted of 12 composite girders. The foundations of each pier consisted of a row of 9 steel tubular piles connected laterally as shown in Figure 5. After the earthquake five girders (G3 to G7) fell into the river as shown.
